Debris/Ice/TPS Assessment and Integrated Photographic Analysis of Shuttle mission STS-105

**DEBRIS/ICE/TPS ASSESSMENT and
INTEGRATED PHOTOGRAPHIC ANALYSIS
OF SHUTTLE MISSION STS-105**

Armando Oliu
Process Engineering/Mechanical System Division/ET-SRB Branch,
Kennedy Space Center, Florida

August 10, 2001

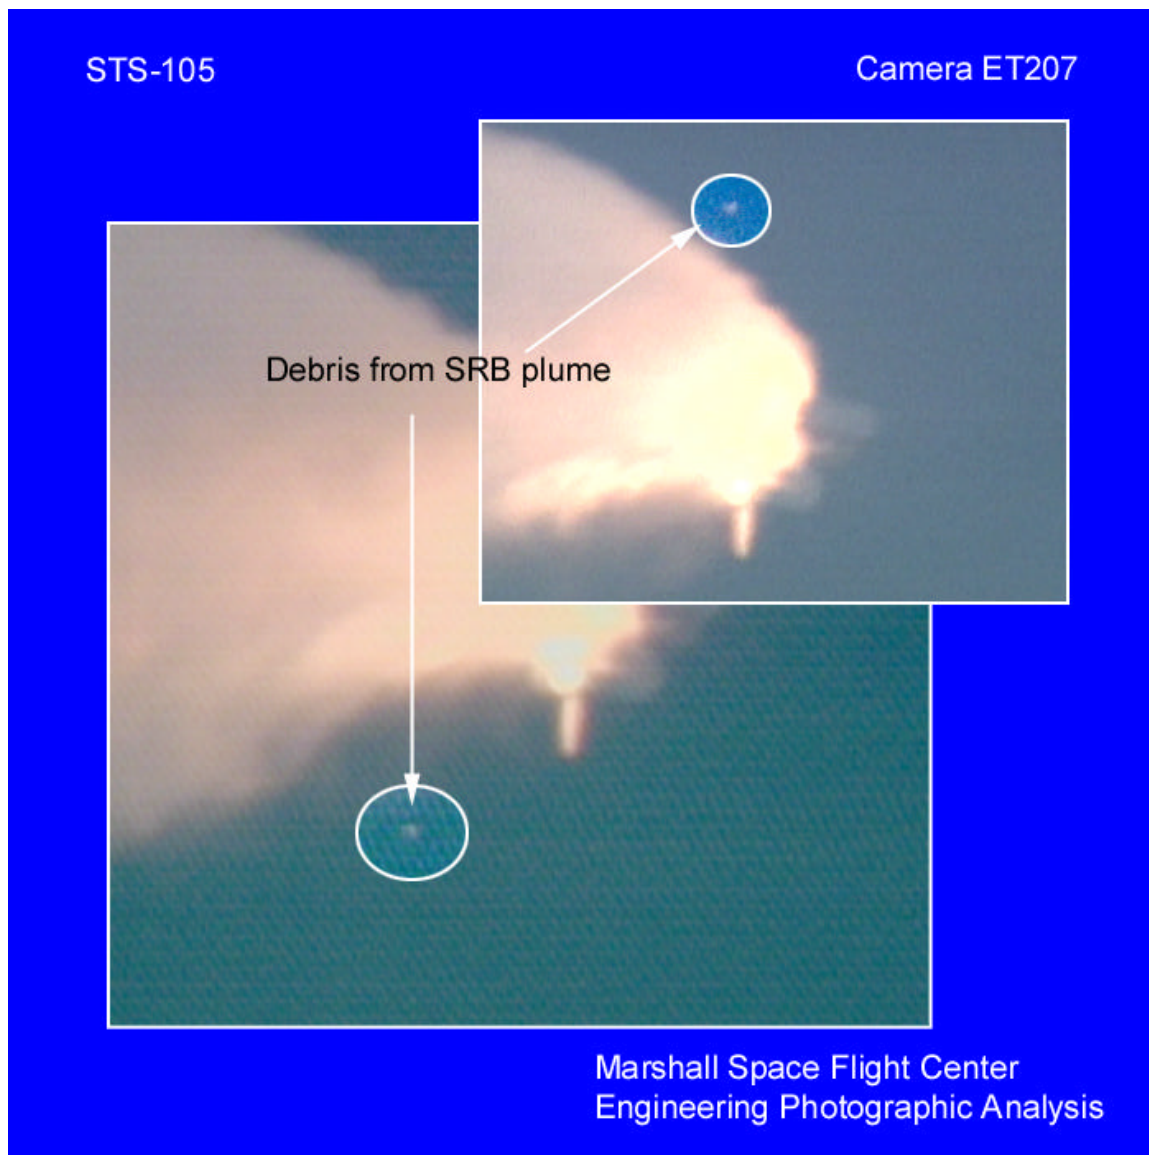
Figure 14. Debris Ejected from SRB Plume

Debris ejected from the SRB plume was observed.

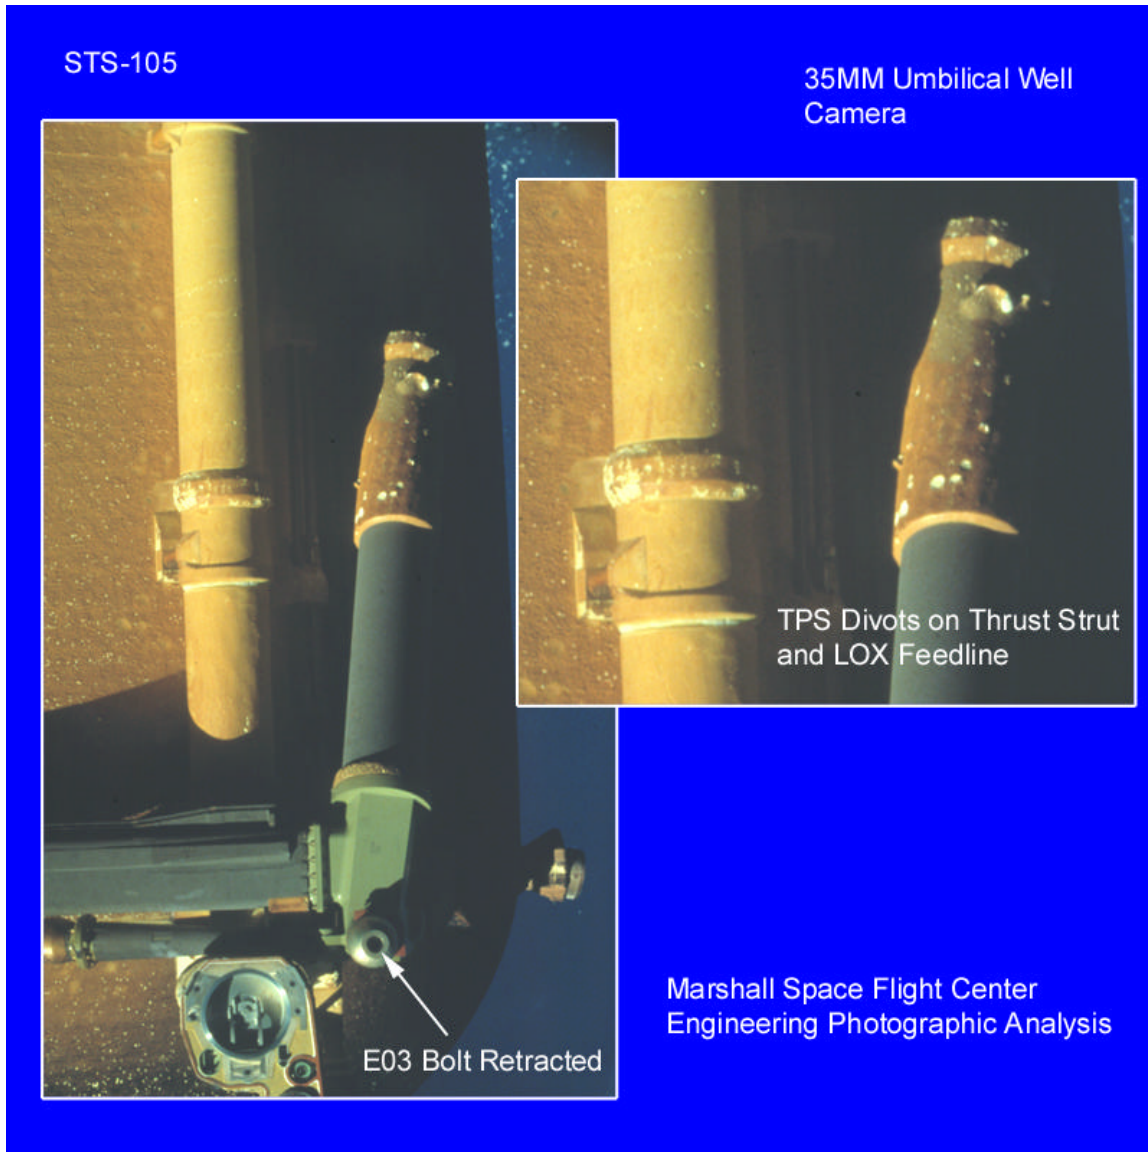
Figure 15. TPS Divots on ET Thrust Strut

Divots in the ET Thrust Strut and LOX Feedline TPS were noted. The EO-3 Separation Bolt was noted to be retracted. Charring and popcorning on the aft dome appeared nominal.

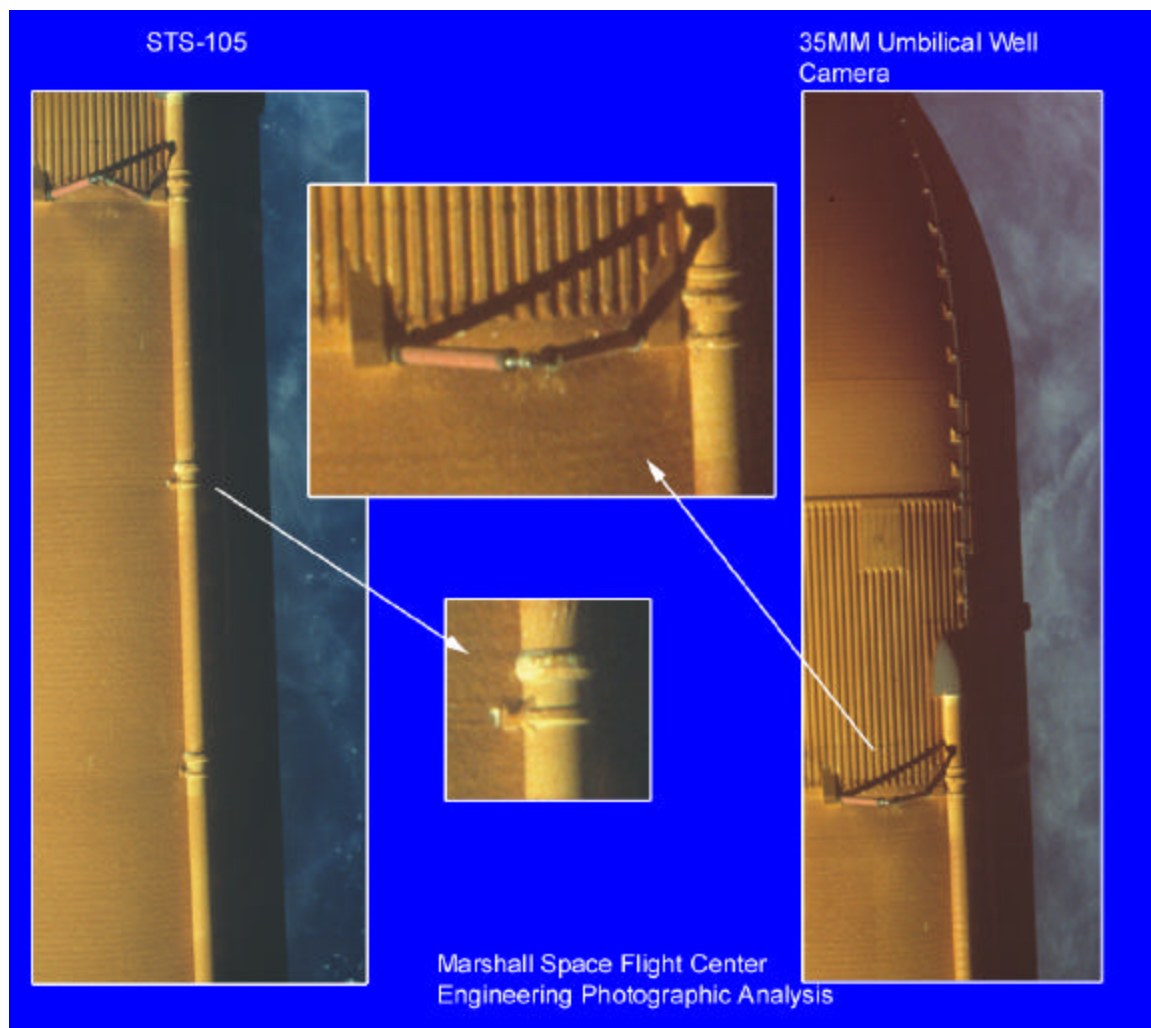
Figure 16. Divots on ET Intertank Acreage

Minor divoting was observed on the Intertank acreage.

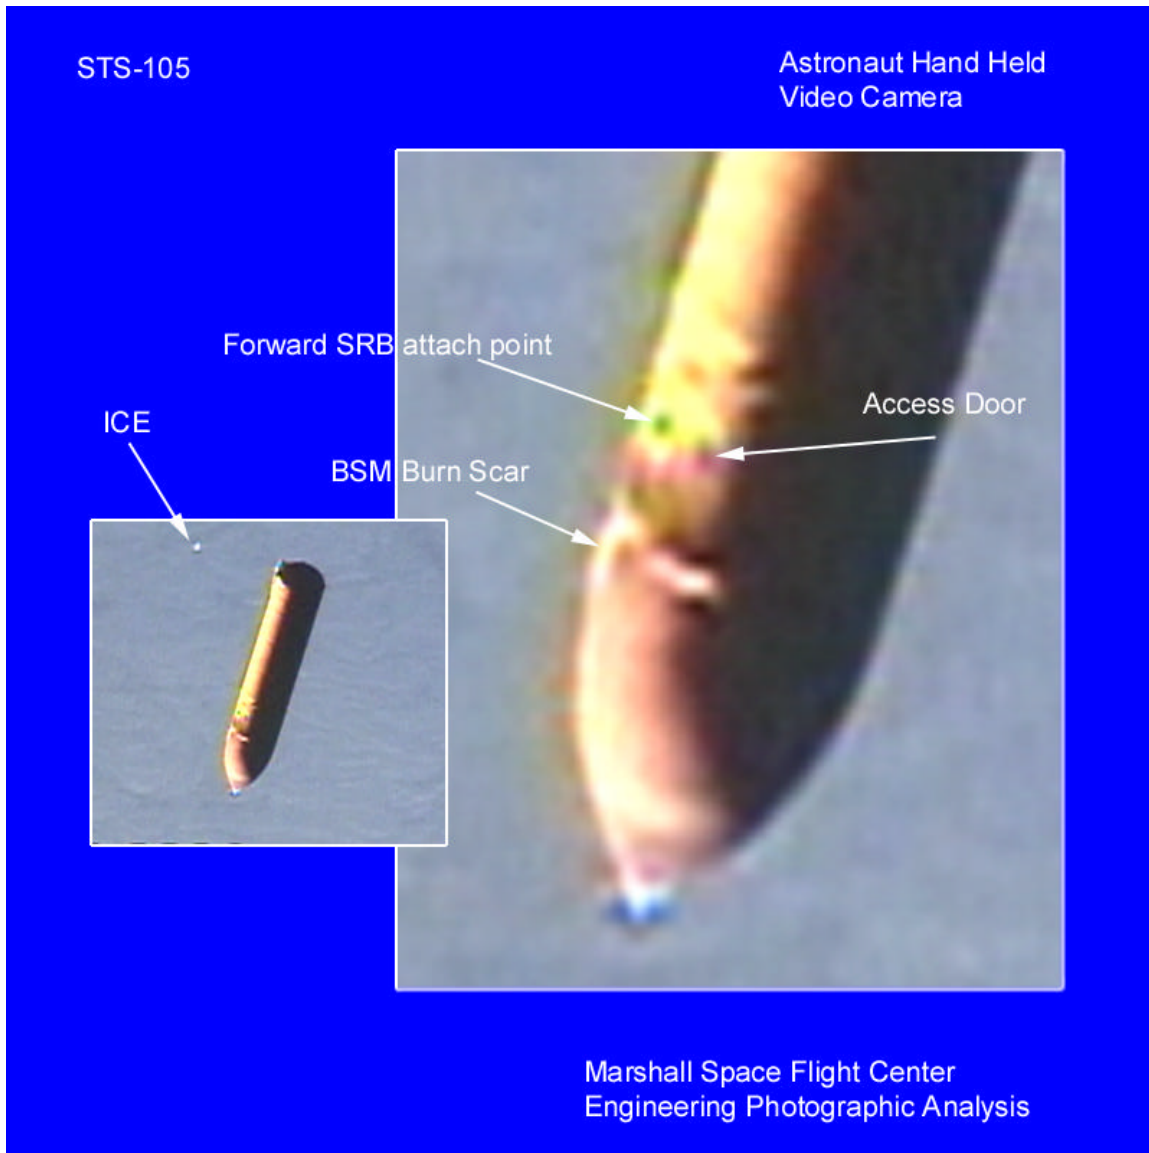
Figure 17. Condition of ET after Separation

Little detail could be resolved due to image size and lighting conditions. No anomalous TPS conditions could be observed.

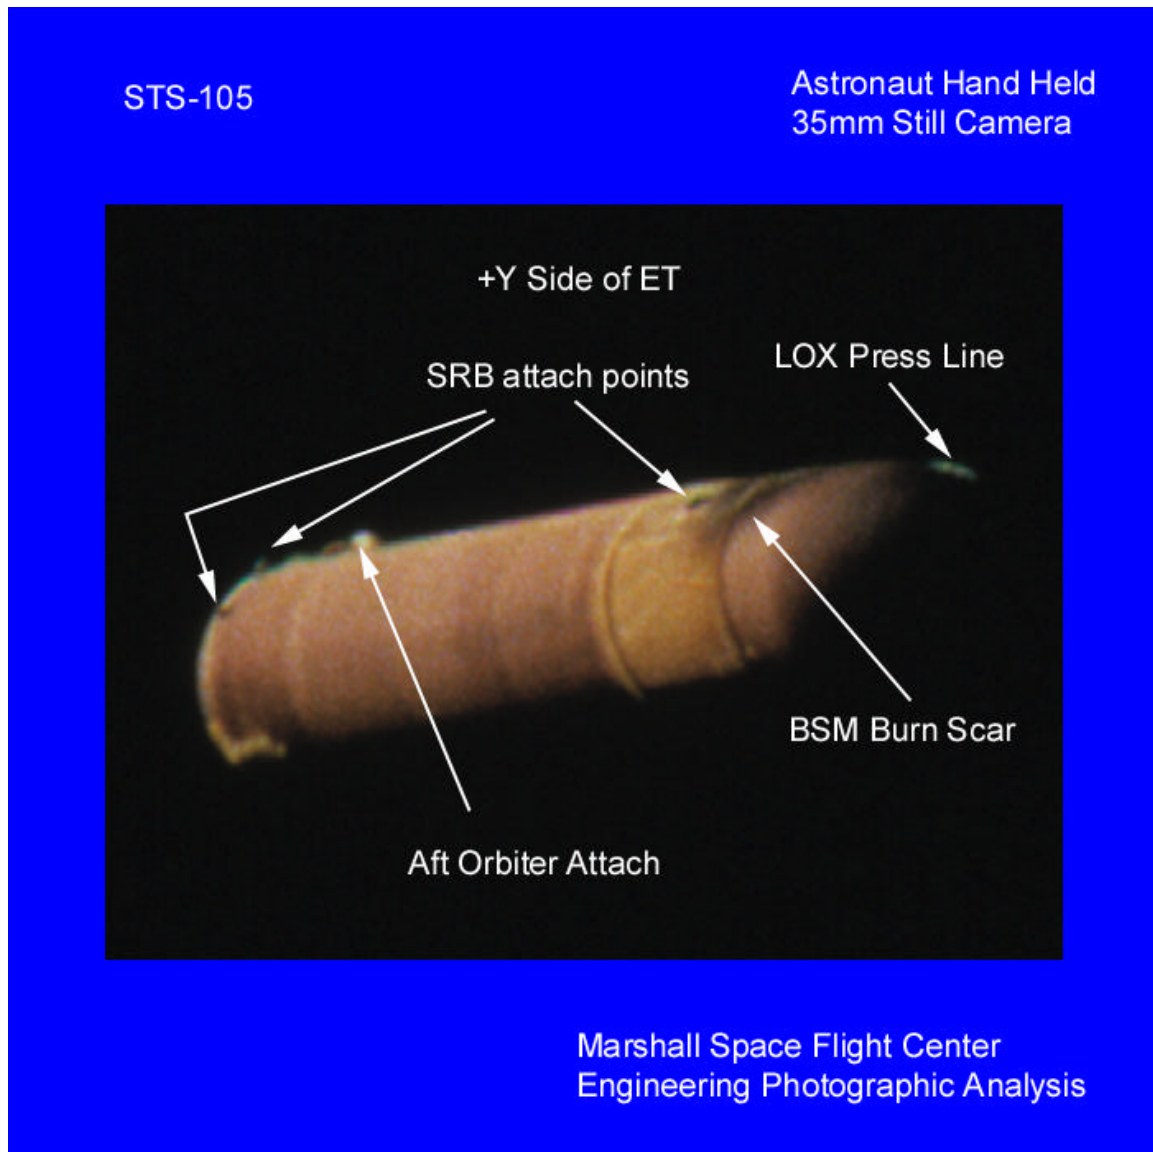
Figure 18. Condition of ET after Separation

Little detail was visible due to the distance of the External Tank from the Orbiter and the lighting conditions. No obvious TPS damage was observed.
